SCAN ON CAUSTIC /WATER WASH TOWER DA 202

Sugiharto*, Wibisono*, Kushartono*, Syurhubel*, Adi Indrajaya** and Mulyanto***

**PT. Chandra Asri Petrochemical Centre

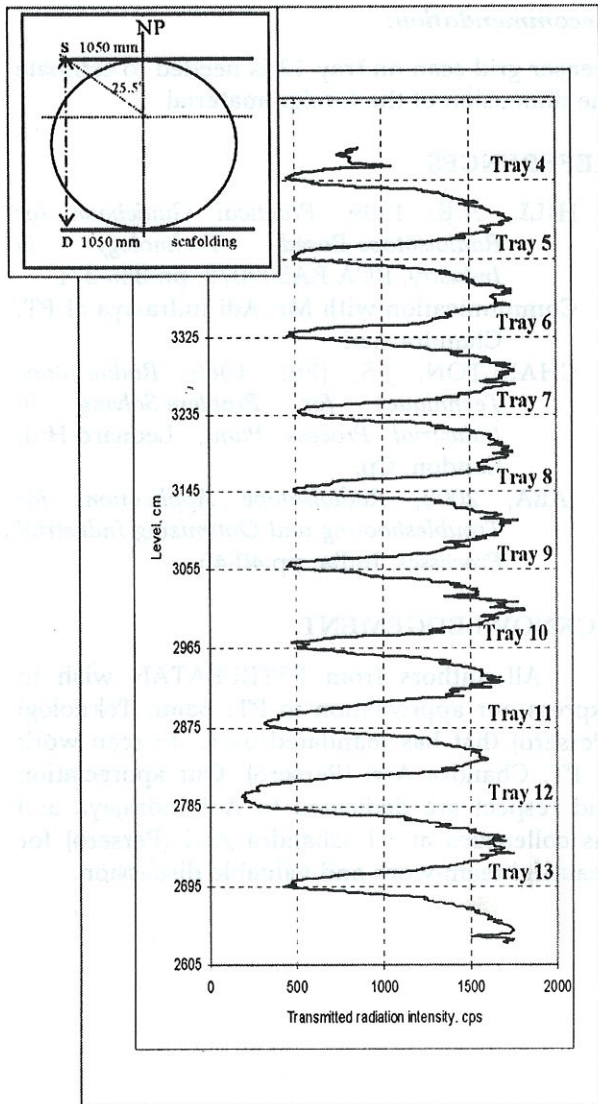
Scan data on caustic/ water wash tower DA 202 show that trays 4 to 10 and tray 13 were in position. They were functioned normally and carried approximately the same amount of liquid. Trays 11 to 12 were in position but they were in trouble. Light flooding on tray 11 and heavy flooding on tray 12 were identified. In addition, suspecting foreign material, which probably solid in character, was identified on tray 12. The conditions of trays are summarized in table 1

Figure 3. Profile of Caustic/ Water Wash Tower DA-202 obtained from scan orientation 1. The scan was carried out on May 24, 2004 at 17:00 p.m. The source and the detector were positioned at 1050 mm (25.5°) and 1050 (154.5°) western North Plant (NP) respectively. Trays 4 to 10 and tray 13 were in position and carried approximately the same amount of liquid. These trays were functioned properly. Light flooding on tray 11 and a heavy flooding on tray 12 were observed as indicated by their lower and wider scan curve. The flooding was probably due to blocking on these trays.

Denser grid scan on tray 12 is needed to estimate the dimension of the foreign material

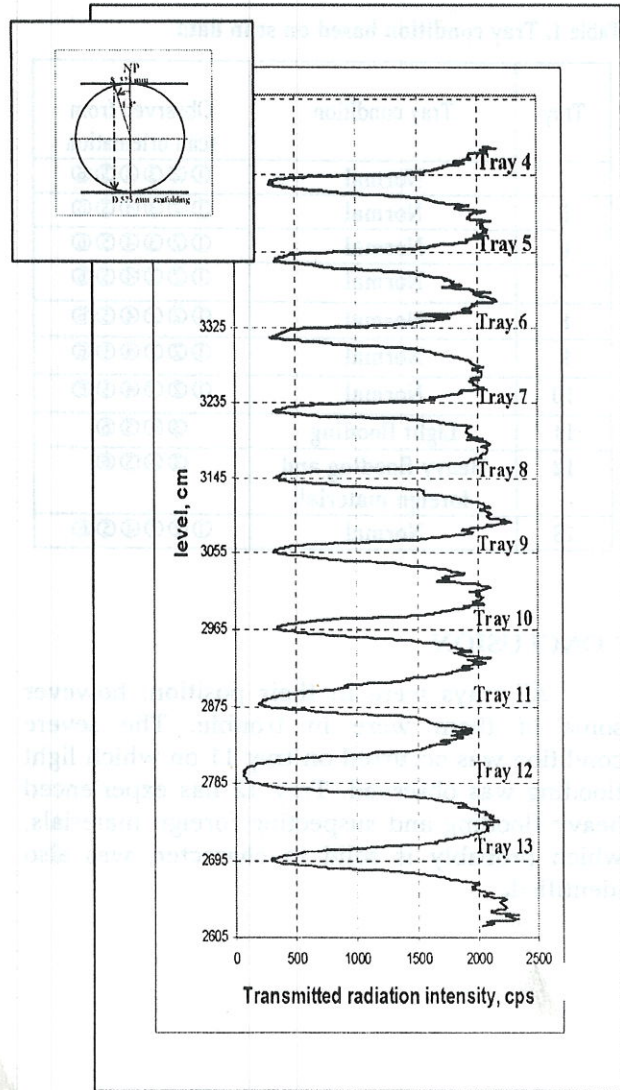
Figure 4. Profile of Caustic/ Water Wash Tower DA-202 obtained from scan orientation 2. The scan was carried out on May 25, 2004 at 12:19 p.m. The source and the detector were positioned 575 mm (1.5°) and 575 mm (178.5°) western North Plant (NP) respectively. Trays 4 to 13 were in position and carried approximately the same amount of liquid. These trays were functioned properly. Light flooding on tray 11 and a heavy flooding on tray 12 were observed as indicated by their lower and wider scan curve. The flooding was probably due to blocking on these trays.

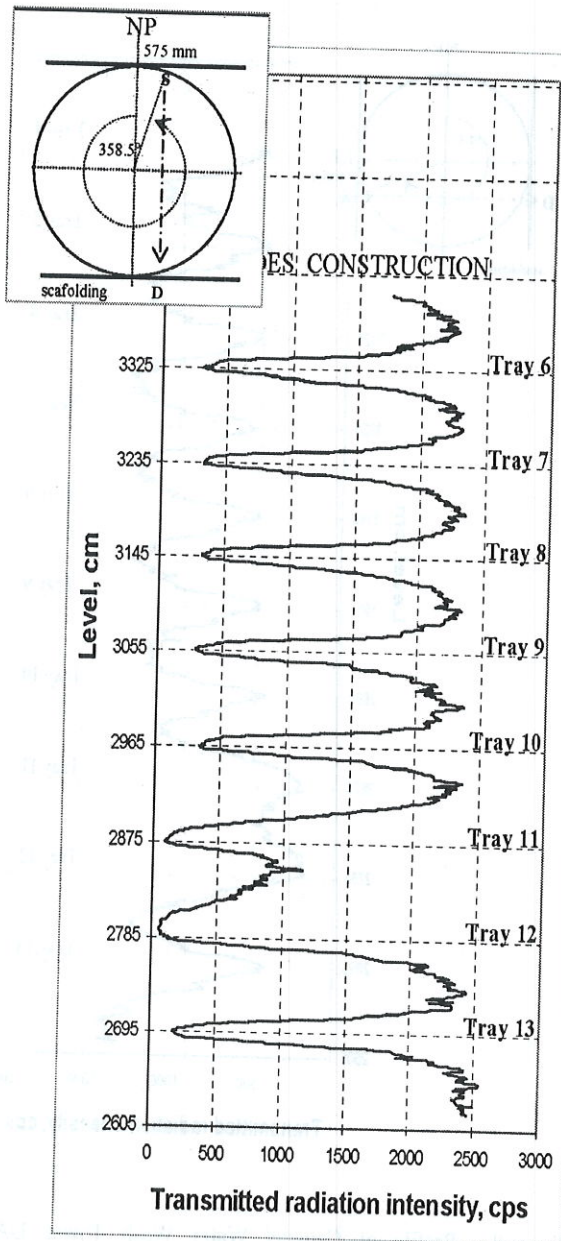
Figure 5. Profile of Caustic/ Water Wash Tower DA-202 obtained from scan orientation 3. The scan was carried out on May 25, 2004 at 17:29 p.m. The source and the detector were positioned 575 mm (181.5°) eastern North Plant (NP) respectively. Trays 6 to 13 were in position and carry approximately the same amount of liquid. Low radiation intensity between tray 11 and 12 was observed indicating a foreign material which probably is solid in character. Light flooding on tray 11 and a heavy flooding on tray 12 were observed as indicated by their lower and wider scan curve. The flooding was probably due to blocking on these trays.

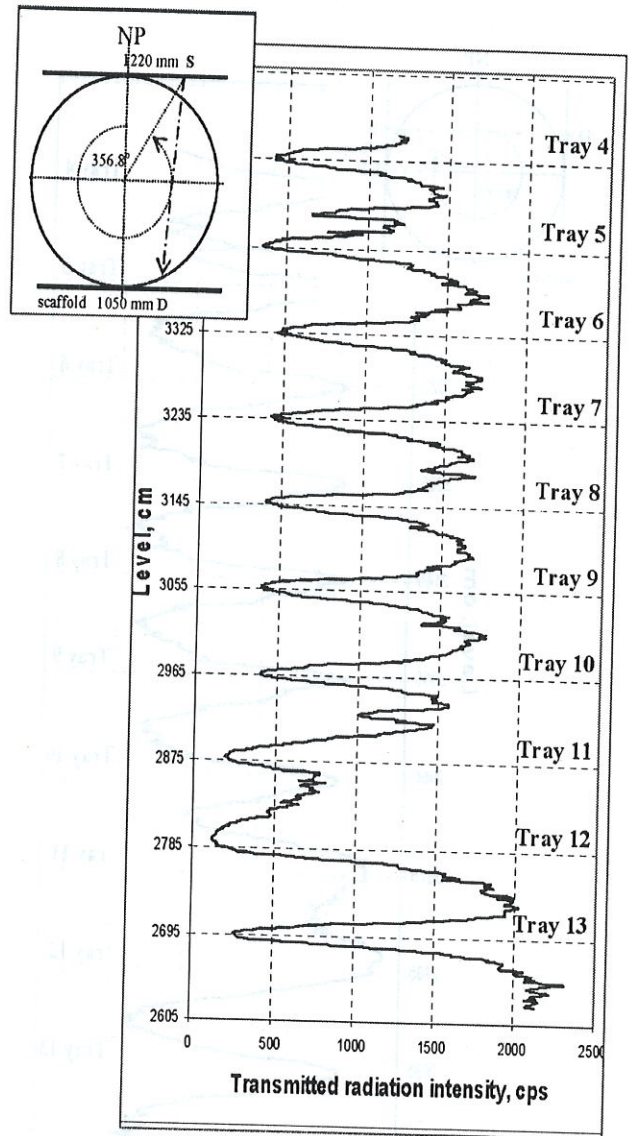
Figure 6. Profile of Caustic/ Water Wash Tower DA-202 obtained from scan orientation 4. The scan was carried out on May 25, 2004 at 16:05 p.m. The source and the detector were positioned 1220 mm (182.7°) eastern North Plant (NP) respectively. Trays 4 to 13 were in position and carry approximately the same amount of liquid. A low intensity between tray 11 and 12 was observed indicating a foreign material which probably is solid in character. Light flooding on tray 11 and heavy flooding on tray 12 were observed as indicated by their lower and wider scan curve. The flooding was probably due to blocking on these trays.

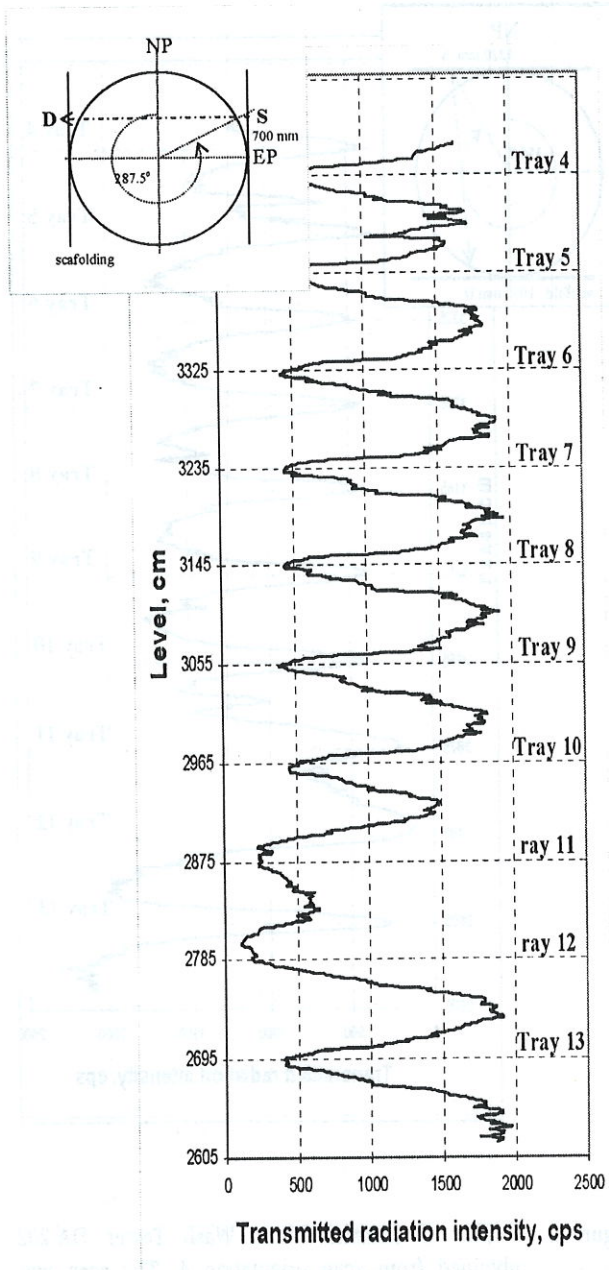
Figure 7. Profile of Caustic/ Water Wash Tower DA-202 obtained from scan orientation 5. The scan was carried out on May 26, 2004 at 9:17 a.m. The source and the detector were positioned 700 mm (287.5°) and 700 mm (72.5°) northern East Plant (EP) respectively. Trays 4 to 13 were in position and carry approximately the same amount of liquid. Low intensity between tray 11 and 12 was observed indicating a foreign material which probably is solid in character. Light flooding on tray 11 and heavy flooding on tray 12 were observed as indicated by their lower and wider scan curve. The flooding was probably due to blocking on these trays.

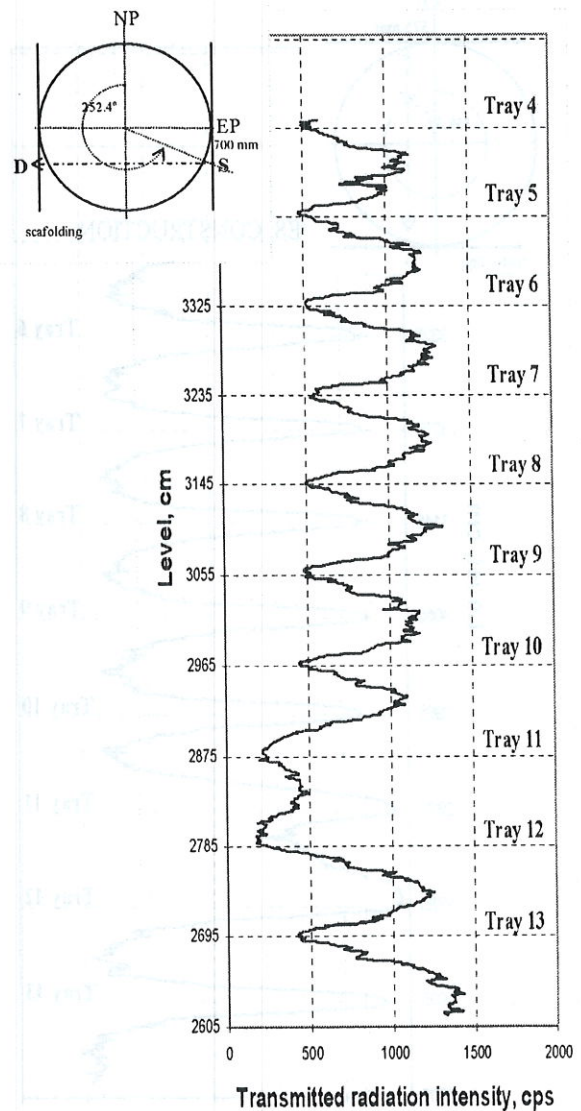
Figure 8. Profile of Caustic/ Water Wash Tower DA-202 obtained from scan orientation 6. The scan was carried out on May 26, 2004 at 11:55 a.m. The source and the detector were positioned 700 mm (252.4°) and 700 mm (107.6°) southern East Plant (EP) respectively. Trays 4 to 13 were in position and carry approximately the same amount of liquid. Low intensity between tray 11 and 12 was observed indicating a foreign material which probably is solid in character. Light flooding on tray 11 and heavy flooding on tray 12 were observed as indicated by their lower and wider scan curve. The flooding was probably due to blocking on these trays.
