# The Effect of Welded Splice with Predetermined Gap of Concrete Spun Pile on The Response of Low Strain Integrity Test

**Abstract:** This paper presents the velocity wave of concrete spun piles with welded splice. The stress wave velocity was recorded using Pile Integrity Test. Two specimens were prepared in the experiment. The first sample was prepared visually no gap between the two end-plates of connected piles, while the second specimen was prepared by inserting 5mm thick steel plate into the splice to create a gap in its connection. The results show that a spike of reflecting stress wave still develops at the splice with and without gap, regardless the splice was welded in full circle. The relatively high spikes of reflecting waves at pile toe are noticed for both specimens with and without gaps. It shows that the full welded splice able to transfer stress wave velocity. A good quality of welded splice can be indicated by the reflecting wave at the pile toe, regardless the reflecting wave development at the splice.

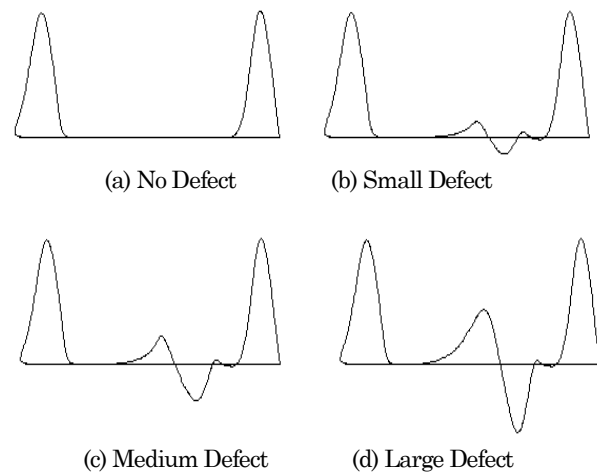
**Figure 2.** Basic Interpretation of PIT

The recorded PIT Graph is a velocity on time domain function, in which wave propagation mechanics illustrated that the pile integration can be interpreted based on pile impedance,  $Z$ . The interpretation of PIT result can be bias because of the number of unknown variable that caused a change of impedance, such as pile defect, soil resistance, pile splice, in-homogenous material, etc. However, the location and severity of pile defect can be interpreted simply by observing the impedance spike on the PIT recorded graph. The basic interpretation are illustrated in Figure 2. Figure 2a shows that the integrity of pile is good since there is no reflecting wave between the two spikes at the head and toe of the pile. The development of spikes of reflecting wave in the area between two spikes at the head and toe of the pile is an indication of defect at the pile. The smaller the spike the smaller the defect, and vice versa, as illustrated in Figure 2b, Figure 2c, and Figure 2d.

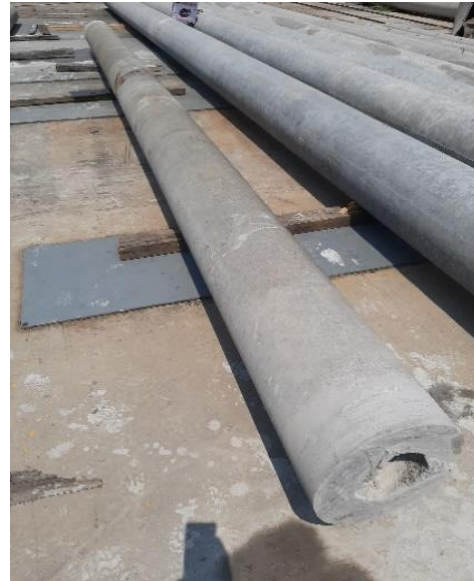
Figure 3. Precast Pile Specimens

The research was performed to investigate the response of recorded stress wave velocity at the welded splice of precast prestressed spun pile diameter of 350 mm using PIT. There were two (2) sets of spun piles connected by welding at its endplates. The splice of the first specimen of pile was welded without any gaps (observed visually) between the two endplates, while the second specimen was prepared with predetermined gap between the two endplates. The gap was generated by inserting a 5 mm thick steel plate. The total length of the specimen was 7000 mm, which was connected in the middle of its length (Figure 3). The pile specimen exhibits concrete strength ( $f_c'$ ) of 42 MPa, 6 PC-bars with diameter of 6 mm, and 6 mm thick steel endplate.

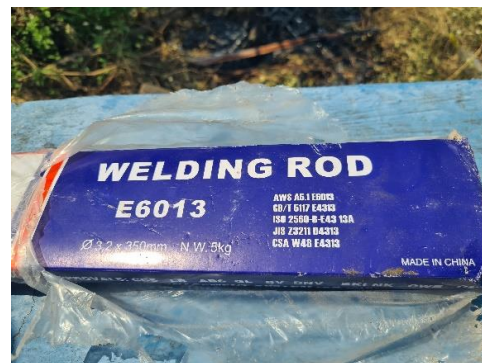
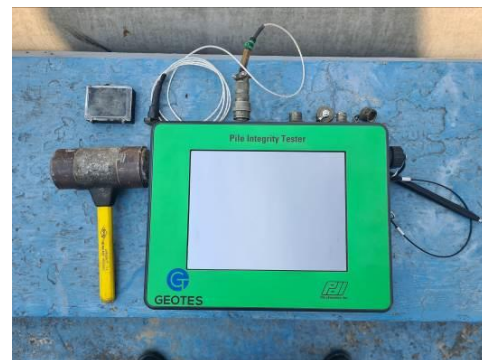
Figure 4. (a) Welding Rod; (b) PIT and its Accessories

The specimen was connected using welding rod type E6013, which has diameter of 3.2 mm (Figure 4a) then tested using low strain integrity apparatus (PIT) as depicted in Figure 4b.

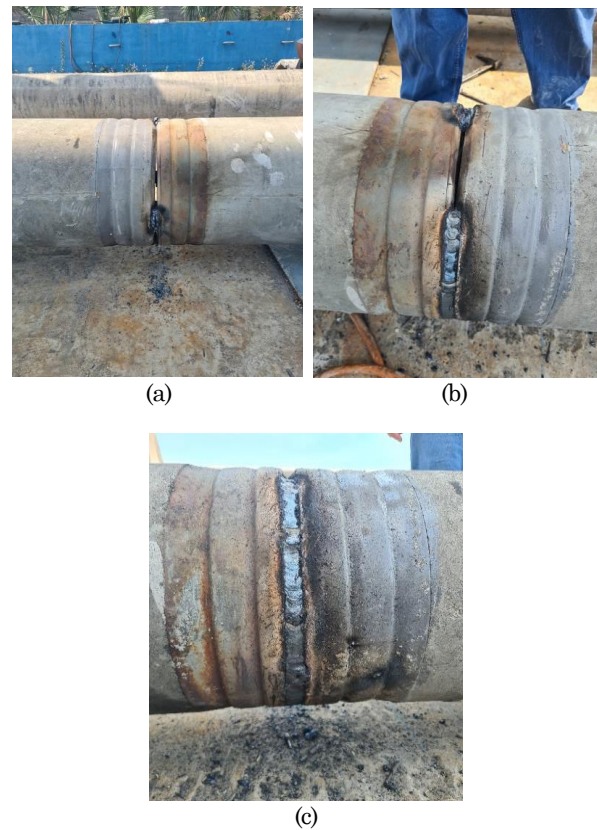
**Figure 7.** (a) Welding at Four Points; (b) Welding at Half Circle; (c) Welding Full Circle

Similar to the preparation steps for specimen with splice without gap, a 5 mm thick steel plate was inserted into the edge of the two endplates as shown in Figure 7a, then three layers of welding were applied in a half circle of the splice (Figure 7b). Finally, the splice was welded fully in three layers (Figure 7c). The three (3) conditions of specimen were tested using PIT.

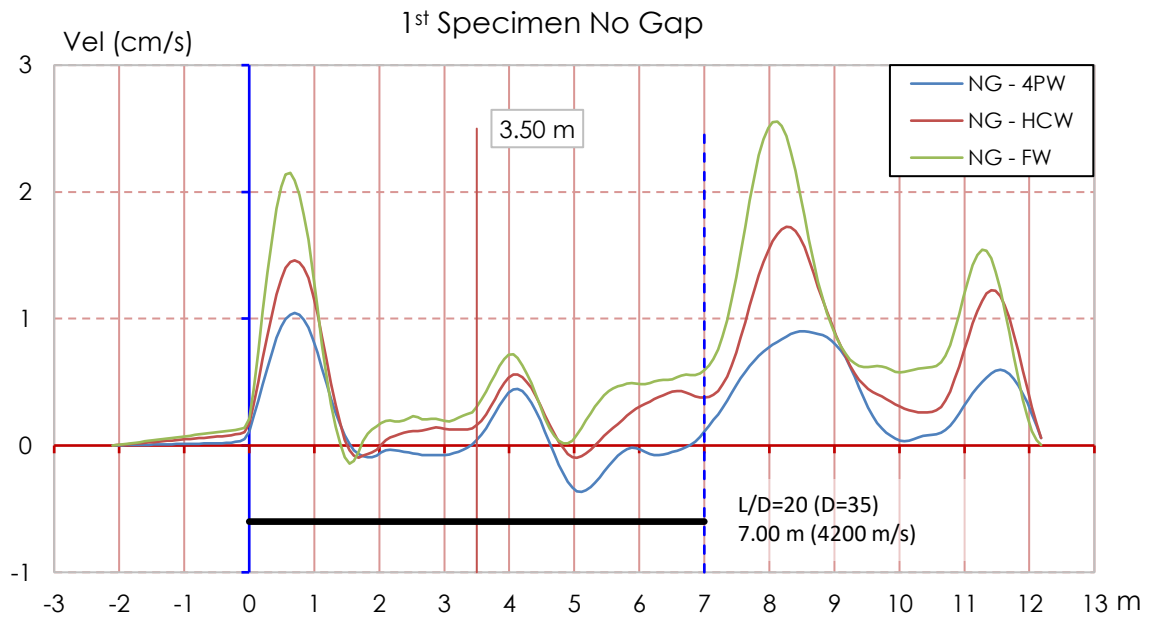
**Figure 8.** Response of Stress Wave at the Splice with no Gap, which were Welded Together at Four Points (NG – 4PW), Half Circle (NG – HCW), and Full Circle (NG – FW)

The results of PIT on the specimen without gap is depicted in Figure 8. It shows that when the splice of the pile is welded at four points (point welded), the stress wave unable to propagate through the splice; the wave is reflected back. In other words, the pile is assumed exhibits the length of 3500mm. When splice was welded half circle of its periphery, a relatively high spike of response wave (reflecting wave) at the distance of 7000mm (pile toe) was observed. The spike of wave velocity is as high as that of the initial one. When the splice was welded in full circle, the spike of recorded reflection wave

velocity at the distance of 7000mm is higher than that at the impact location. Figure 8 shows that the spike of wave velocity at the distance of 7000mm increases with the welded area at the splice. The spike of reflecting wave velocity at the splice that was welded in full circle might be caused by a gap that still exist between the endplates regardless visually there was no gap noticed. The gap can not be entirely closed since there was no special efforts

to push the two segments of the specimen to contact each other, to replicate the welding process of a splice in the field, where to upper pile that will be connected is laid down in fully contact on the pile head of the lower pile previously installed.

The splice that was prepared visually without gap still exhibits gap, which changes the impedance of the specimen so that generates reflecting wave that recorded as spike of wave velocity

The spike of reflecting wave velocity at 7000 mm (pile toe) for splice welded at four points relatively lower than that of initial impact. It is very likely the repetition of reflecting wave (spike) at 3500 mm (at the splice) rather than the wave response at the distance of 7000 mm (pile toe) since the stress wave can not propagate through the splice
