CHARACTERISTICS OF PHYSICAL CATCHMENT AT LAKE BUYAN AND LAKE TAMBLINGAN, BALI - INDONESIA

Luki Subehi¹, Hendro Wibowo¹, Iwan Ridwansyah¹

¹Research Centre for Limnology, Indonesian Institute of Sciences, Cibinong 16911, Indonesia
luki@limnologi.lipi.go.id

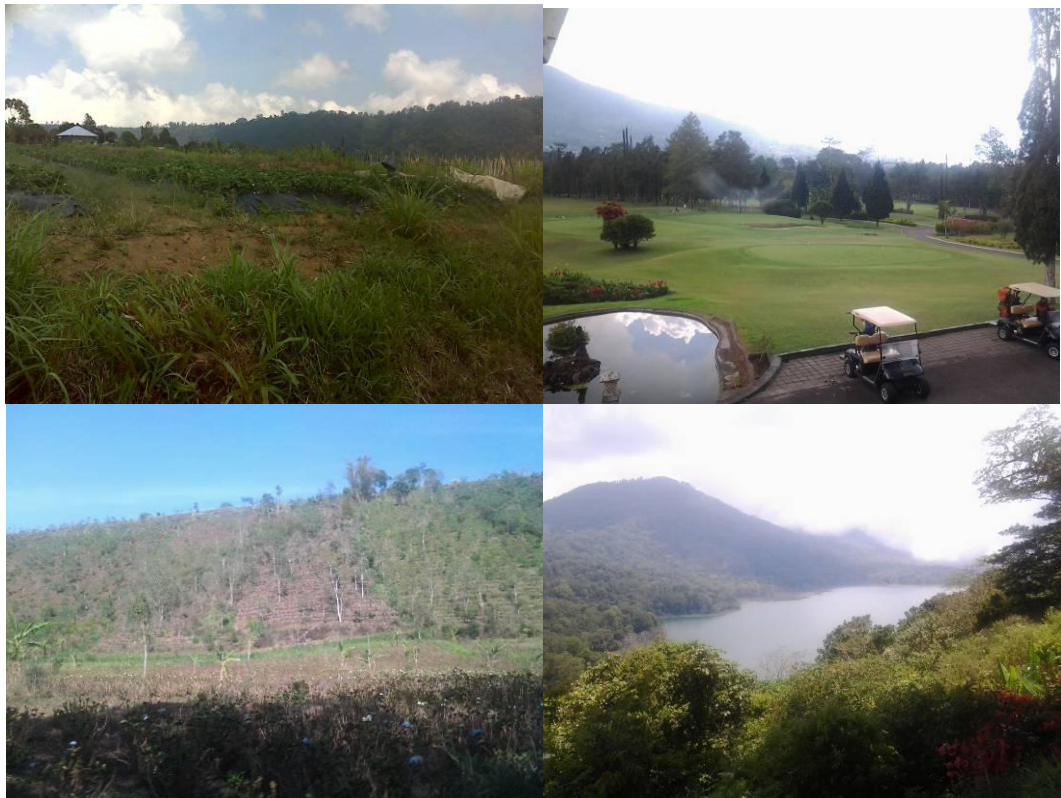
Land use at Buyan-Tamblingan catchment was obtained from Landsat satellite image classification results in 2012. Land use classes used by Indonesian RBI (Rupa Bumi Indonesia) maps, scale 1: 25,000, published by Bakosurtanal (BIG). RBI map is also used as a comparison in the analysis of land use changes in the catchment. Based on RBI map, land use at Buyan-Tamblingan catchment in 1994 was dominated by forest cover with an area of 2,335.8 ha or reaches 63% of the total area of the catchment and lake. The area of lakes reached 626 ha (17%). Figure 3 shows the land use at Buyan-Tamblingan catchment on October 2012, such as plantation, agriculture, sport area (golf), part of clear cutting forest , etc.

Fig. 3 Land use at Buyan-Tamblingan catchment

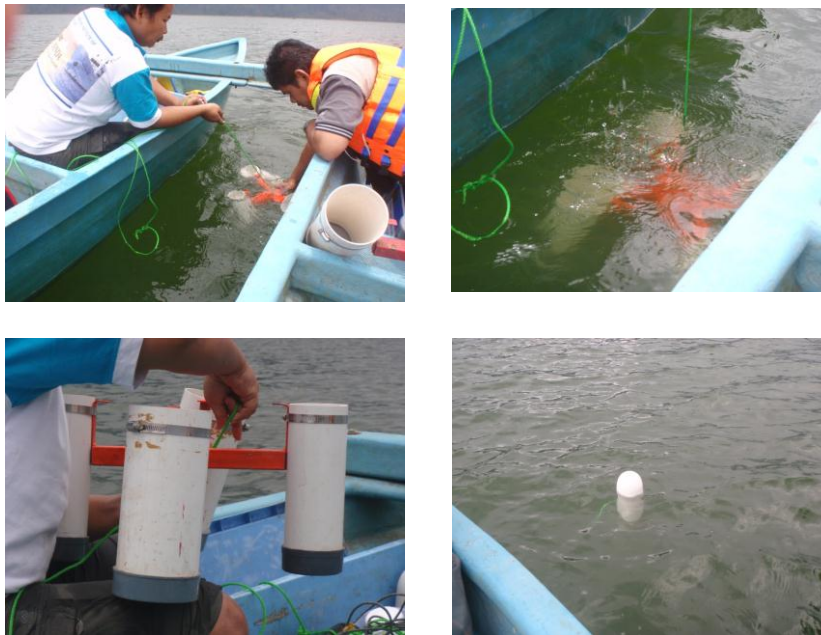
Fig.6 Survey activities at Lake Buyan and Lake Tamblingan

Next, sedimentation rates in the lake can be approached with the installation of a sediment trap tubes mounted on the 0.6 part of the depth of the lake (Fig. 6). The total weight of the sediment is trapped in the tube for long installation time is the value of the velocity sedimentation. Measurements were made at two points at Lake Buyan and one point at Lake Tamblingan (Fig. 7). In addition, no inflow coming from the catchment showed total particulate deposition changes as shown in Table 3.
